NDI ID PA 00640

## LAKE AKIBA DAM

### PHASE I INSPECTION REPORT NATIONAL DAM INSPECTION PROGRAM

Name of Dam:	Lake Akiba Dam
State:	Pennsylvania
County:	Monroe
Stream:	Sandspring Creek
Coordinates:	N40°59.3', W75°21.3'
Dates of Inspections:	May 20, 1981 & June 1, 1981

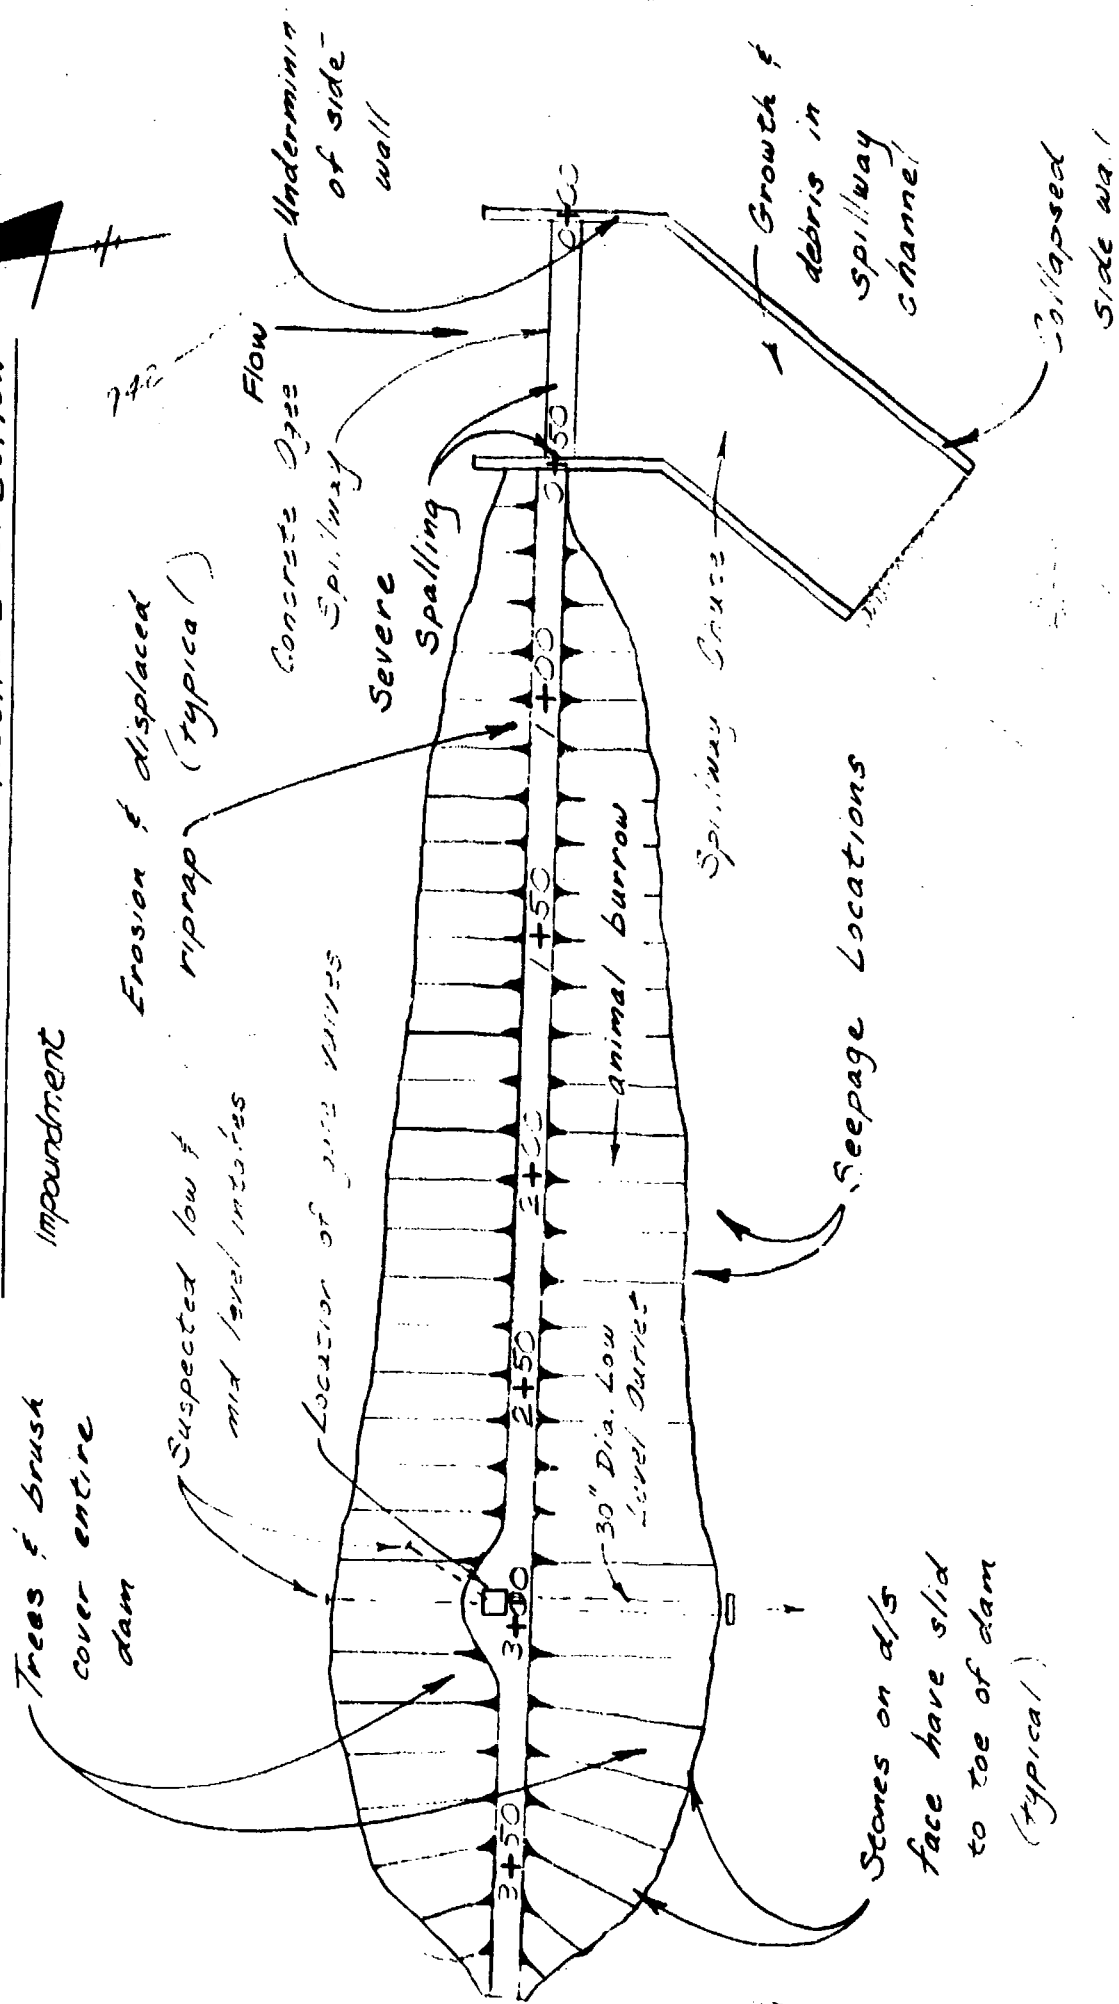
LOCATION PLAN OF DEFICIENCIES  
OBSERVED DURING VISUAL INSPECTION

Seepage was found at two locations to the east of the outlet works (See sheet 11A of Appendix A). It was estimated to be approximately one gallon per minute at the western most location and no flow was observed at the other location (Photo 8, Appendix C).
